# Access Compliance Report Public Rights-of-Way (Curb Ramps)

| Main Street: LEAFWOOD_LN | | Cross Street: DALL_LN | | Location: | SE |
| ADA ID: RPAT211019111455 | Ramp Type:Type 1 - Perpendicular Diagonal Initial Pass/Fail: Fail | | Overall Compliance: No | Severity Score: | 15 |

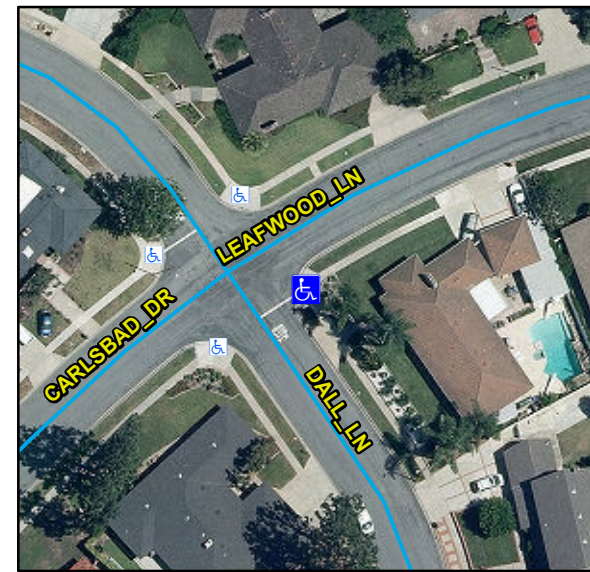
| Compliance | Description | Data | Compliance | Description | Data |
|---|---|---|---|---|---|
| No | Ramp Run Slope (%) | 8.4 | N/A | Flare Slope LT (%) | N/A |

**Remove & Replace Curb Ramp With Two New Directional Ramps or Equivalent.**

**R204.3, R304.2.2, STD 1115**

Total Cost: \$ 6160

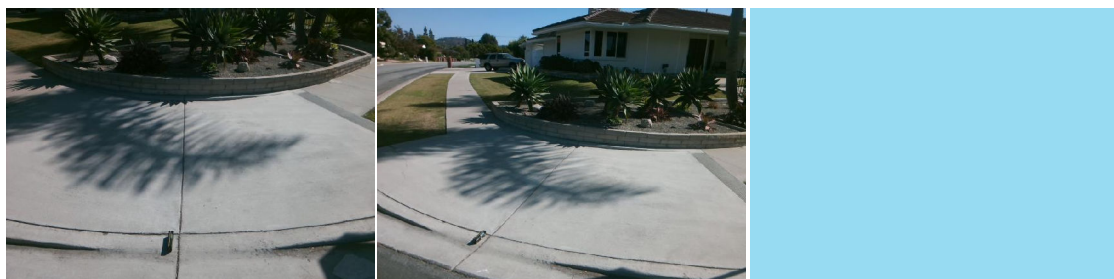
| Compliance | Description | Data | Compliance | Description | Data |
|---|---|---|---|---|---|
| Yes | Ramp Width (in) | 53 | | | N/A |
| Yes | Ramp Cross Slope (%) | 0.7 | N/A | Flare Traversable LT | N/A |
