# Access Compliance Report Public Rights-of-Way (Curb Ramps)

Main Street: WINTHROPE\_ST Cross Street: DODGE\_AVE Location: NE

ADA ID: RPAT211019125827 Ramp Type: Type 1 - Perpendicular Diagonal Initial Pass/Fail: Pass Overall Compliance: No Severity Score: 0

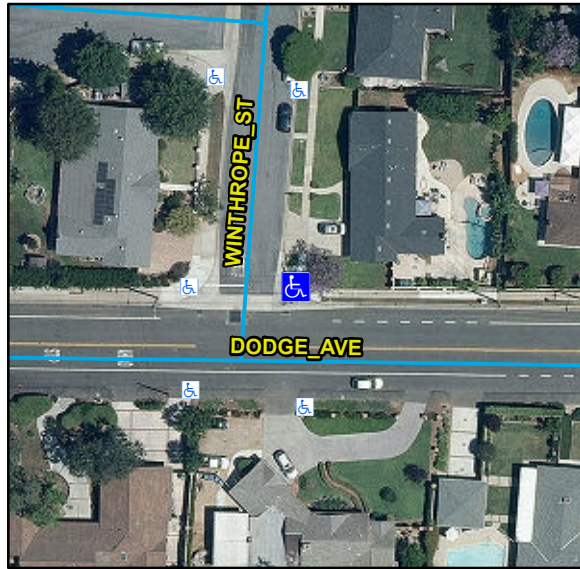
| Compliance | Description | Data | Compliance | Description | Data |
|---|---|---|---|---|---|
| N/A | Landing Movement Obstructed? | Yes | Yes | DWS Contrast | Yes |
| | Landing Movement Type | Curb | Yes | DWS Length (in) | 36 |

Remove & Replace Landing.

R304.2.1, STD 1115
