# Access Compliance Report Public Rights-of-Way (Curb Ramps)

Main Street: DODGE\_AVE Cross Street: WINTHROPE\_ST Location: NW

ADA ID: RPAT211019130331 Ramp Type: Type 1 - Perpendicular Diagonal Initial Pass/Fail: Fail Overall Compliance: No Severity Score: 2

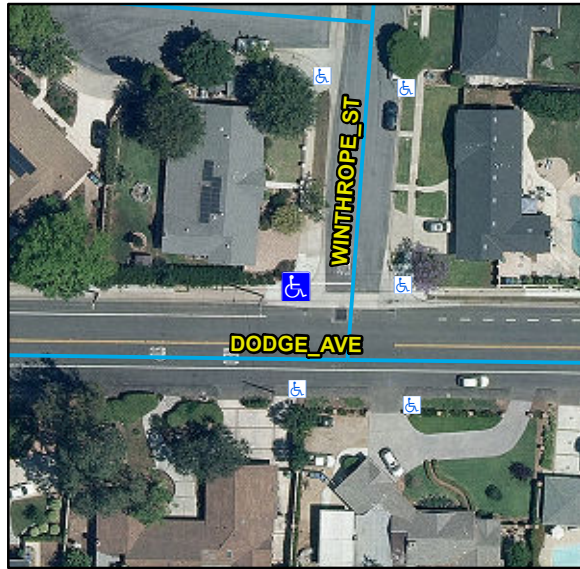
| Compliance | Description | Data | Compliance | Description | Data |
|---|---|---|---|---|---|
| No | Ramp Cross Slope (%) | 3.8 | N/A | Flare Traversable LT | N/A |

**Remove & Replace Curb Ramp With Two New Directional Ramps or Equivalent.**

**R304.2.2, R304.5.3, STD 1115**
