# Access Compliance Report Public Rights-of-Way (Curb Ramps)

Main Street: SANDHURST\_PL Cross Street: DODGE\_AVE Location: NE

ADA ID: RPAT211019131018 Ramp Type: Type 1 - Perpendicular Diagonal Initial Pass/Fail: Pass Overall Compliance: No Severity Score: 4

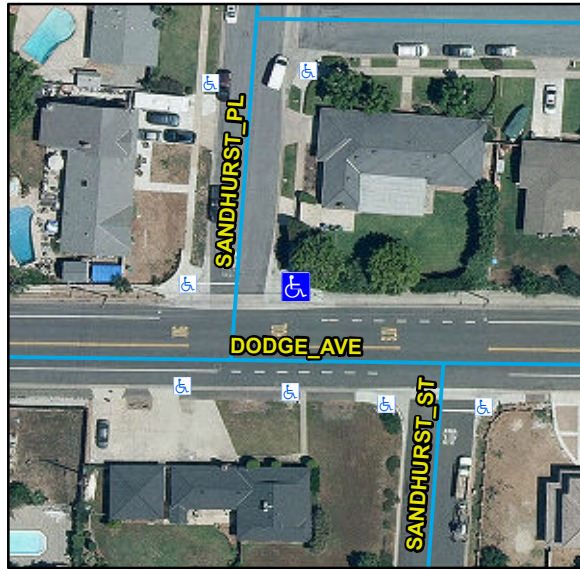
| Compliance | Description | Data | Compliance | Description | Data |
|---|---|---|---|---|---|
| No | Landing Width (in) | 47 | N/A | Flare Slope RT (%) | 7 |
| Yes | Gutter Ponding | No | No | Curb Slope | 8.1 |

**Remove & Replace Curb Ramp With Two New Directional Ramps or Equivalent.**

**R304.2.2, R304.2.1, STD 1115**
