# Access Compliance Report Public Rights-of-Way (Curb Ramps)

Main Street: DODGE\_AVE Cross Street: SANDHURST\_PL Location: NW

ADA ID: RPAT211019131546 Ramp Type: Type 1 - Perpendicular Diagonal Initial Pass/Fail: Pass Overall Compliance: No Severity Score: 4

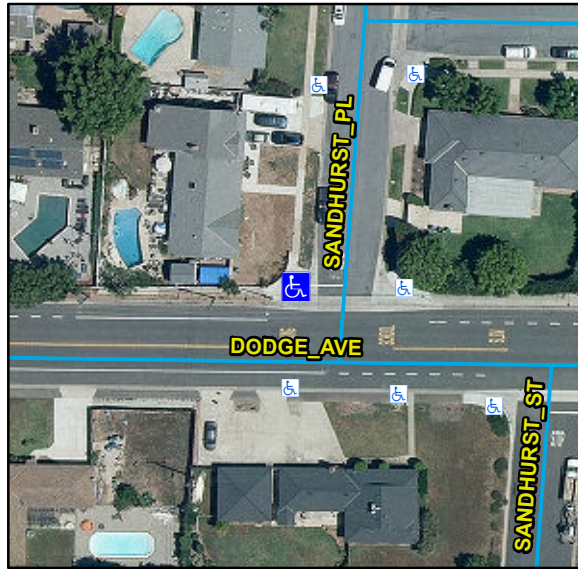
| Compliance | Description | Data | Compliance | Description | Data |
|---|---|---|---|---|---|
| Yes | Gutter Ponding | No | No | Curb Slope | 9.7 |
| No | Gutter Cross Slope (%) | 2.1 | | | |

Remove & Replace Curb Ramp With Two New Directional Ramps or Equivalent. Remove & Replace Gutter.

R304.2.2, R304.2.1, R304.5.3, STD 1115
