# Access Compliance Report Public Rights-of-Way (Curb Ramps)

Main Street: E\_EL\_SALVADOR\_AVE Cross Street: S\_ESPANITA\_ST Location: NW

ADA ID: RPAT211019144052 Ramp Type: Type 1 - Perpendicular Diagonal Initial Pass/Fail: Pass Overall Compliance: No Severity Score: 8

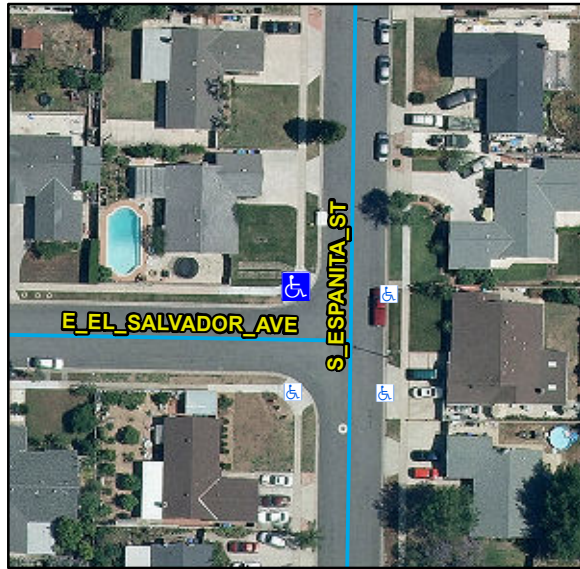
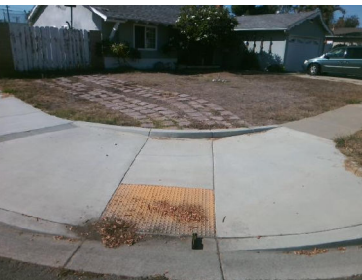
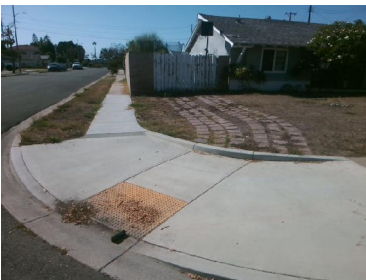
| Compliance | Description | Data | Compliance | Description | Data |
|---|---|---|---|---|---|
| No | Gutter Ponding | Yes | Yes | Curb Slope | 3.6 |

**Remove & Replace Landing. Gutter Ponding Observed.**

**R304.2.1, R302.7, STD 1115**
