# Access Compliance Report Public Rights-of-Way (Curb Ramps)

Main Street: S\_ESPANITA\_ST Cross Street: E\_EL\_SALVADOR\_AVE Location: SW

ADA ID: RPAT211019144431 Ramp Type: Type 1 - Perpendicular Diagonal Initial Pass/Fail: Pass Overall Compliance: No Severity Score: 6

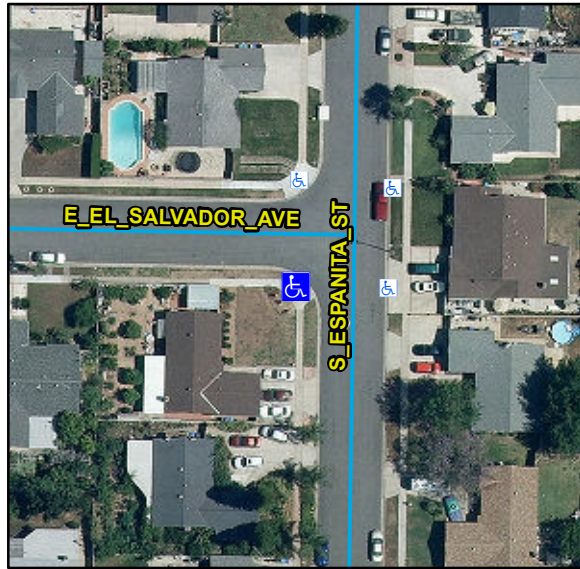
| Compliance | Description | Data | Compliance | Description | Data |
|---|---|---|---|---|---|
| Yes | Gutter Ponding | No | No | Curb Slope | 9.3 |
| No | Gutter Run Slope (%) | 11.4 | | Road Cross Slope (%) | 3.8 |

Remove & Replace Curb Ramp With Two New Directional Ramps or Equivalent. Remove & Replace Gutter.
