# Access Compliance Report Public Rights-of-Way (Curb Ramps)

Main Street: EL\_CARMEN\_AVE Cross Street: HEWES\_ST Location: SE

ADA ID: RPAT211020083122 Ramp Type:Type 1 - Perpendicular Diagonal Initial Pass/Fail: Pass Overall Compliance: No Severity Score: 4

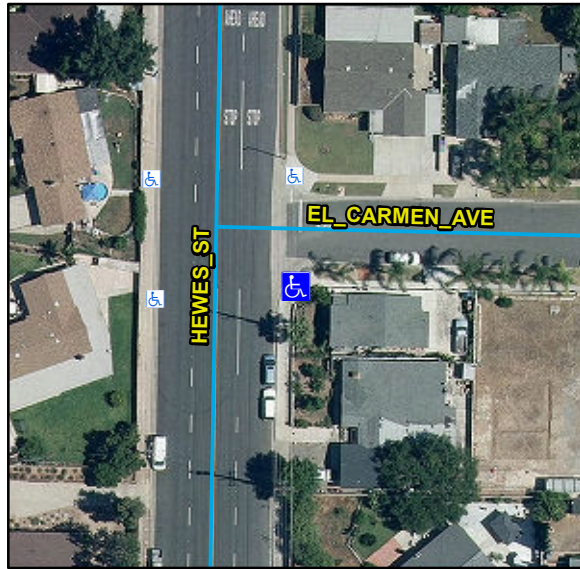
| Compliance | Description | Data | Compliance | Description | Data |
|---|---|---|---|---|---|
| No | Landing Run Slope (%) | 2.5 | N/A | Flare Traversable RT | No |
| No | Landing Cross Slope (%) | 2.6 | Yes | DWS Provided | Yes |
| Yes | Gutter Ponding | No | No | Curb Slope | 6.8 |

Remove & Replace Curb Ramp With Two New Directional Ramps or Equivalent.

R304.2.2, R304.2.1, R304.2.2-Perp, R304.3.2-Para, R304.5.3, STD 1115
