# Access Compliance Report Public Rights-of-Way (Curb Ramps)

Main Street: HEWES\_ST Cross Street: EL\_CARMEN\_AVE Location: NE

ADA ID: RPAT211020083646 Ramp Type: Type 1 - Perpendicular Diagonal Initial Pass/Fail: Pass Overall Compliance: No Severity Score: 4

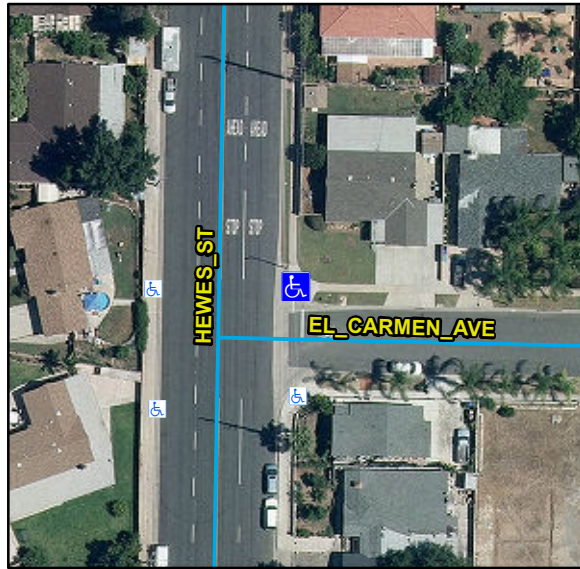
| Compliance | Description | Data | Compliance | Description | Data |
|---|---|---|---|---|---|
| N/A | Landing Present | Yes | N/A | Flare Type RT | |
| N/A | Landing Length (in) | 46 | | | Sloped |
| N/A | Landing Movement Obstructed? | Yes | Yes | DWS Contrast | Yes |
| | Landing Movement Type | Curb | Yes | DWS Length (in) | 36 |

Possible Solutions:

Remove & Replace Landing.

R304.2.1, STD 1115

Total Cost: \$ 531
