# Access Compliance Report Public Rights-of-Way (Curb Ramps)

Main Street: HEWES\_ST Cross Street: E\_ORANGE\_GROVE\_AVE Location: NE

ADA ID: RPAT211020084324 Ramp Type: Type 1 - Perpendicular Diagonal Initial Pass/Fail: Pass Overall Compliance: No Severity Score: 0

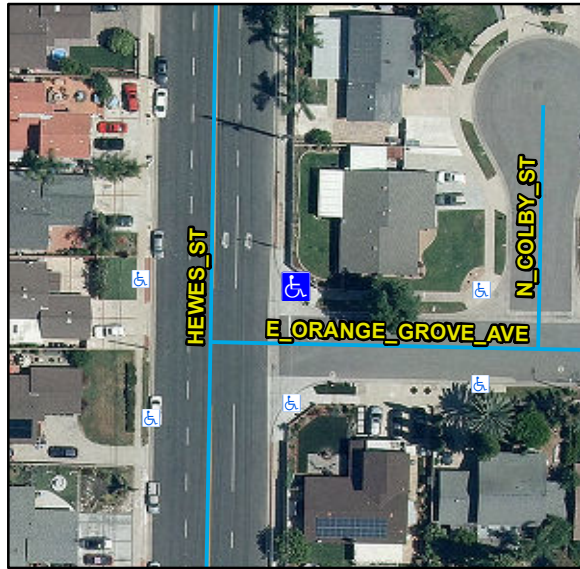
| Compliance | Description | Data | Compliance | Description | Data |
|---|---|---|---|---|---|
| Yes | Gutter Ponding | No | No | Curb Slope | 7.9 |

Remove & Replace Curb Ramp With Two New Directional Ramps or Equivalent.

R304.2.2, R304.2.1, STD 1115

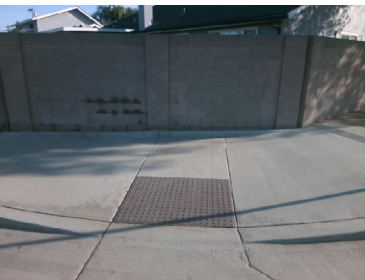
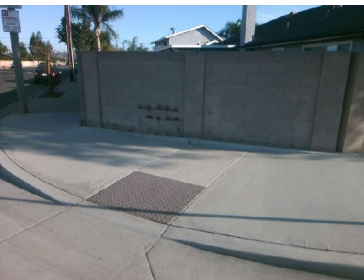
| Compliance | Description | Data | Compliance | Description | Data |
|---|---|---|---|---|---|
| Yes | Overall Surface Condition: Acceptable | | Yes | Perp Joint Present | Yes |
