# Access Compliance Report Public Rights-of-Way (Curb Ramps)

Main Street: E\_ORANGE\_GROVE\_AVE Cross Street: HEWES\_ST Location: SE

ADA ID: RPAT211020084908 Ramp Type: Type 1 - Perpendicular Diagonal Initial Pass/Fail: Fail Overall Compliance: No Severity Score: 2

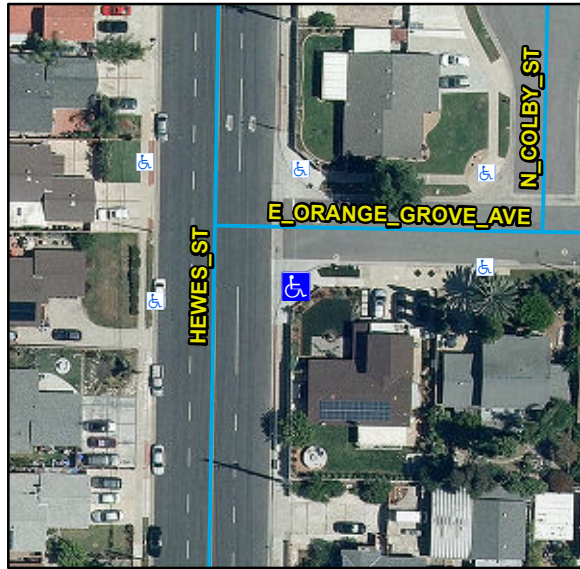
| Compliance | Description | Data | Compliance | Description | Data |
|---|---|---|---|---|---|
| No | Ramp Cross Slope (%) | 3.8 | N/A | Flare Traversable LT | N/A |

Remove & Replace Curb Ramp With Two New Directional Ramps or Equivalent.

R304.2.2, R304.5.3, STD 1115
