# Access Compliance Report Public Rights-of-Way (Curb Ramps)

Main Street: E\_ORANGE\_GROVE\_AVE Cross Street: N\_COLBY\_ST Location: NW

ADA ID: RPAT211020085305 Ramp Type: Type 1 - Perpendicular Diagonal Initial Pass/Fail: Fail Overall Compliance: No Severity Score: 20

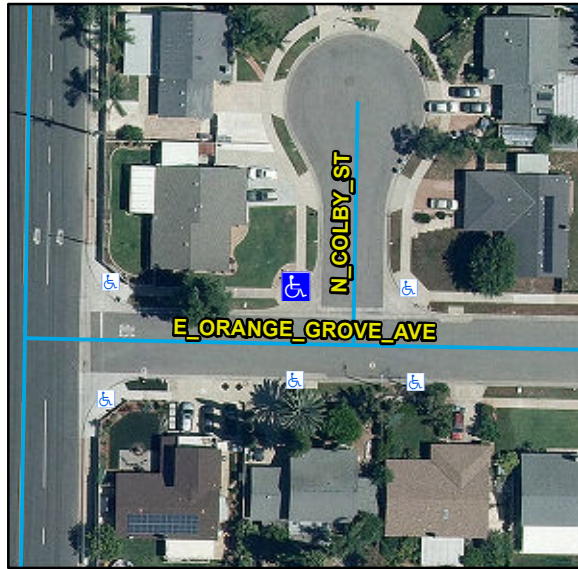
| Compliance | Description | Data | Compliance | Description | Data |
|---|---|---|---|---|---|
| No | Ramp Width (in) | 46 | | | N/A |
| No | Ramp Run Slope (%) | 10.5 | N/A | Flare Slope LT (%) | N/A |

Remove & Replace Curb Ramp With Two New Directional Ramps or Equivalent.

R304.2.2, R204.3, R304.5.1, STD 1115
