# Access Compliance Report Public Rights-of-Way (Curb Ramps)

Main Street: N\_COLBY\_ST Cross Street: E\_ORANGE\_GROVE\_AVE Location: NE

ADA ID: RPAT211020085605 Ramp Type: Type 1 - Perpendicular Diagonal Initial Pass/Fail: Fail Overall Compliance: No Severity Score: 32

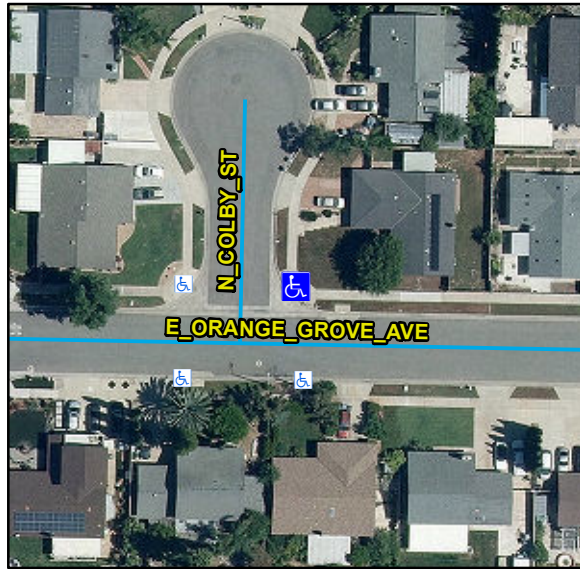
**R304.2.2, R204.3, STD 1115**

| Compliance | Description | Data | Compliance | Description | Data |
|---|---|---|---|---|---|
| No | Ramp Run Slope (%) | 13.5 | N/A | Flare Slope LT (%) | N/A |

**Remove & Replace Curb Ramp With Two New Directional Ramps or Equivalent.**
