# Access Compliance Report Public Rights-of-Way (Curb Ramps)

Main Street: BOND\_AVE Cross Street: S\_CHURCH\_ST Location: SE

ADA ID: RPAT211020091155 Ramp Type: Type 1 - Perpendicular Diagonal Initial Pass/Fail: Fail Overall Compliance: No Severity Score: 15

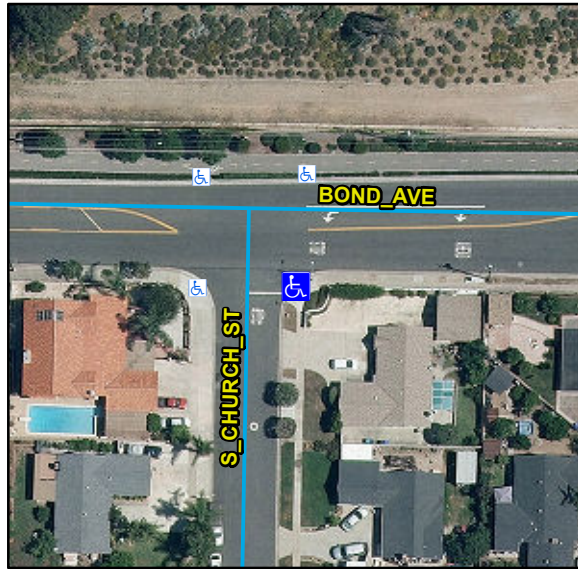
| Compliance | Description | Data | Compliance | Description | Data |
|---|---|---|---|---|---|
| No | Ramp Run Slope (%) | 9 | N/A | Flare Slope LT (%) | N/A |

Remove & Replace Curb Ramp With Two New Directional Ramps or Equivalent.

R304.2.2, STD 1115
