# Access Compliance Report Public Rights-of-Way (Curb Ramps)

| Main Street: S_CHURCH_ST | | Cross Street: BOND_AVE | | Location: | SW |
| ADA ID: RPAT211020091515 | Ramp Type:Type 1 - Perpendicular Diagonal Initial Pass/Fail: Pass | | Overall Compliance: No | Severity Score: | 10 |

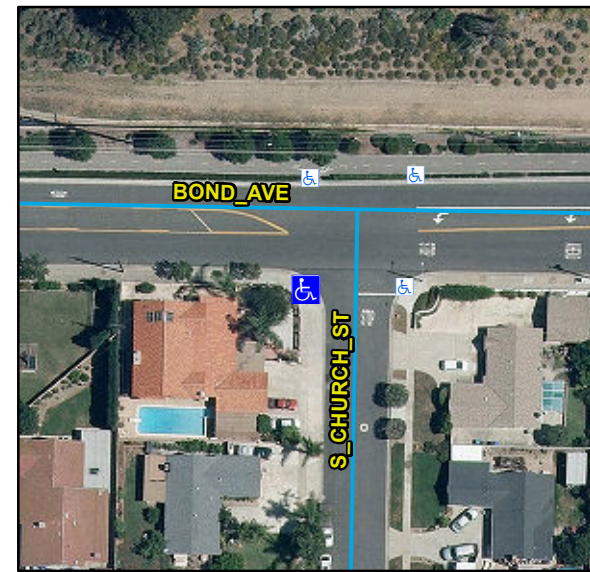
R304.2.2, R304.2.1, R304.5.4, STD 1115

Remove & Replace Curb Ramp With Two New Directional Ramps or Equivalent. Remove & Replace Gutter.

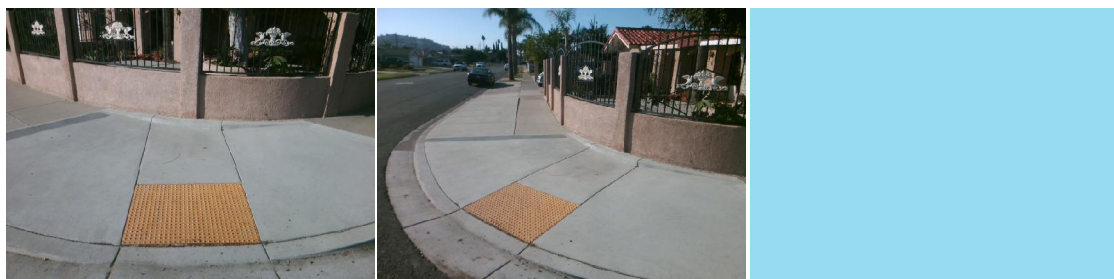
| Compliance | Description | Data | Compliance | Description | Data |
|---|---|---|---|---|---|
| Yes | Gutter Ponding | No | No | Curb Slope | 7.5 |
| No | Gutter Run Slope (%) | 5.7 | | Road Cross Slope (%) | 5.2 |
