# Access Compliance Report Public Rights-of-Way (Curb Ramps)

| Main Street: BOND_AVE | | Cross Street: BOND_AVE | | Location: | NW |
| ADA ID: RPAT211020091947 | Ramp Type:Type 1 - Perpendicular | Initial Pass/Fail: Fail | Overall Compliance: No | Severity Score: | 32 |

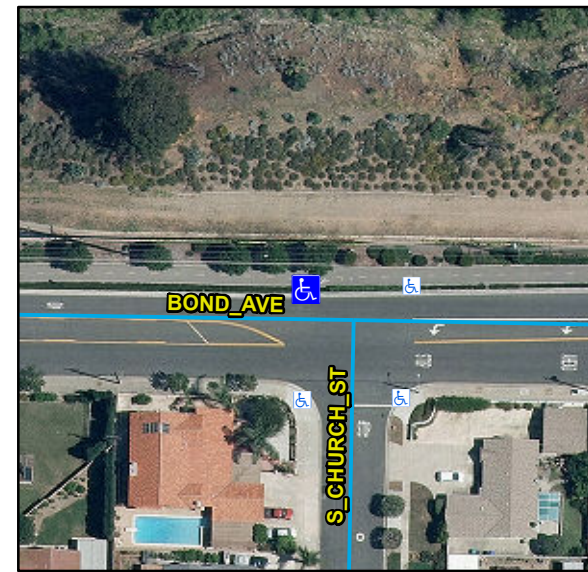
| Compliance | Description | Data | Compliance | Description | Data |
|---|---|---|---|---|---|
| No | Ramp Run Slope (%) | 14.4 | N/A | Flare Slope LT (%) | N/A |
| No | Ramp Cross Slope (%) | 2.4 | N/A | Flare Traversable LT | N/A |

Possible Solutions:

Remove & Replace Entire Ramp.

R304.2.2, R304.5.3, STD 1115

\$ 3080

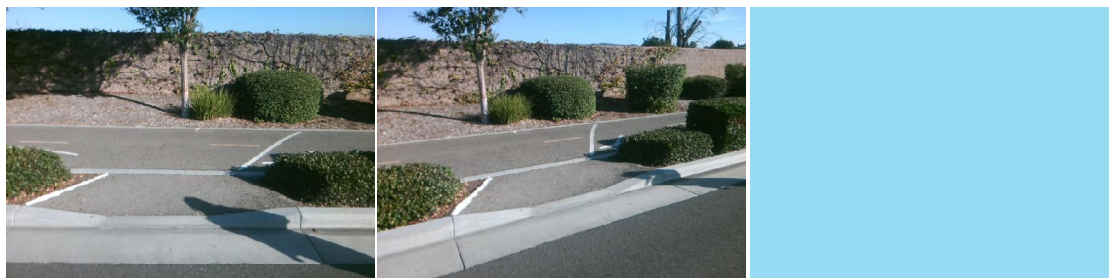
| Compliance | Description | Data | Compliance | Description | Data |
|---|---|---|---|---|---|
| N/A | Ramp Length (in) | 38 | N/A | Flare Type LT | |
| Yes | Ramp Width (in) | 48 | | | N/A |
| Yes | Gutter Lip Height (in) | 0 | | Road Run Slope (%) | N/A |
| Yes | Overall Surface Condition: Acceptable | | Yes | Perp Joint Present | Yes |
