# Access Compliance Report Public Rights-of-Way (Curb Ramps)

Main Street: S\_CHURCH\_ST Cross Street: EL\_CARMEN\_AVE Location: NE

ADA ID: RPAT211020092725 Ramp Type: Type 1 - Perpendicular Diagonal Initial Pass/Fail: Pass Overall Compliance: No Severity Score: 4

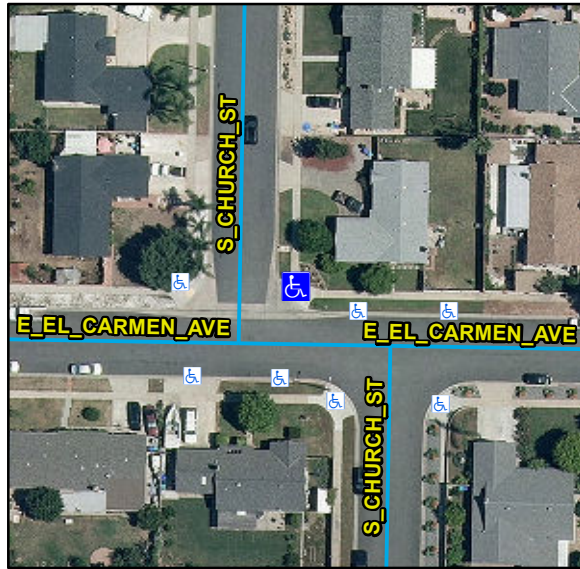
| Compliance | Description | Data | Compliance | Description | Data |
|---|---|---|---|---|---|
| No | Landing Run Slope (%) | 2.3 | N/A | Flare Traversable RT | No |

Remove & Replace Landing.
