# Access Compliance Report

## Public Rights-of-Way

### (Curb Ramps)

Main Street: E\_EL\_CARMEN\_AVE Cross Street: S\_CHURCH\_ST Location: SE

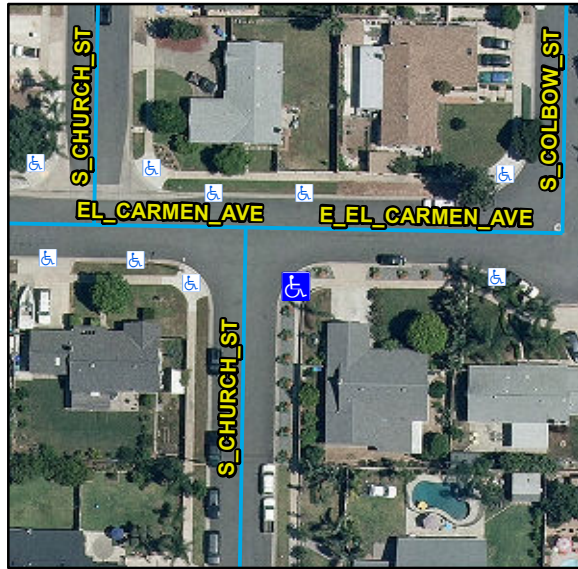
ADA ID: RPAT211020093621 Ramp Type: Type 1 - Perpendicular Diagonal Initial Pass/Fail: Pass Overall Compliance: No Severity Score: 9

#### Field Measurements/Component Compliance

Remove & Replace Curb Ramp With Two New Directional Ramps or Equivalent. Remove & Replace Gutter.

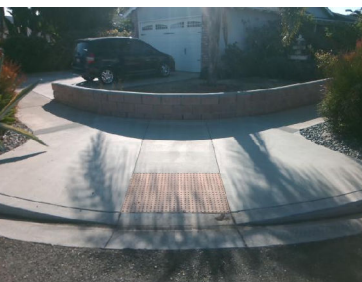
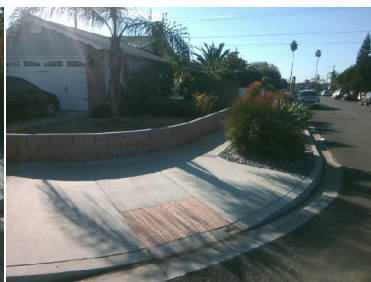
| Compliance | Description | Data | Compliance | Description | Data |
|---|---|---|---|---|---|
| Yes | Gutter Ponding | No | No | Curb Slope | 10.4 |
| No | Gutter Run Slope (%) | 10.6 | | Road Cross Slope (%) | 7.1 |
