Main Street: EARLHAM\_ST Cross Street: E\_EL\_CARMEN\_AVE Location: NE

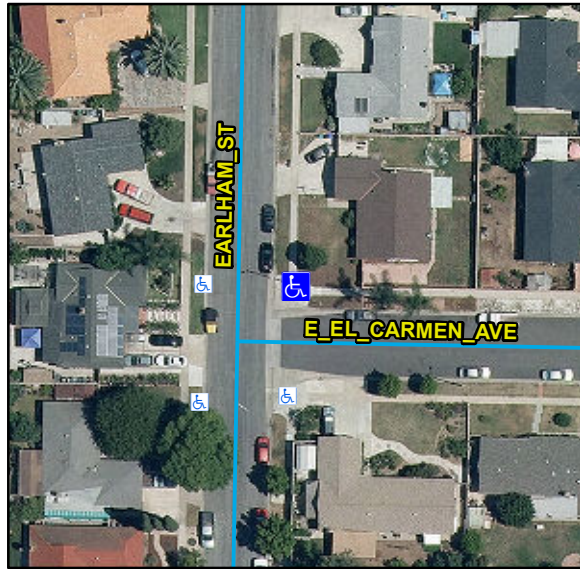
ADA ID: RPAT211020095021 Ramp Type: Type 1 - Perpendicular Diagonal Initial Pass/Fail: Pass Overall Compliance: No Severity Score: 4

Remove & Replace Curb Ramp With Two New Directional Ramps or Equivalent.

R304.2.2, R304.2.1, STD 1115
