# Access Compliance Report Public Rights-of-Way (Curb Ramps)

Main Street: S\_CHURCH\_ST Cross Street: WALNUT\_AVE Location: NE

ADA ID: RPAT211020101233 Ramp Type: Type 4 - Parallel Initial Pass/Fail: Pass Overall Compliance: No Severity Score: 5

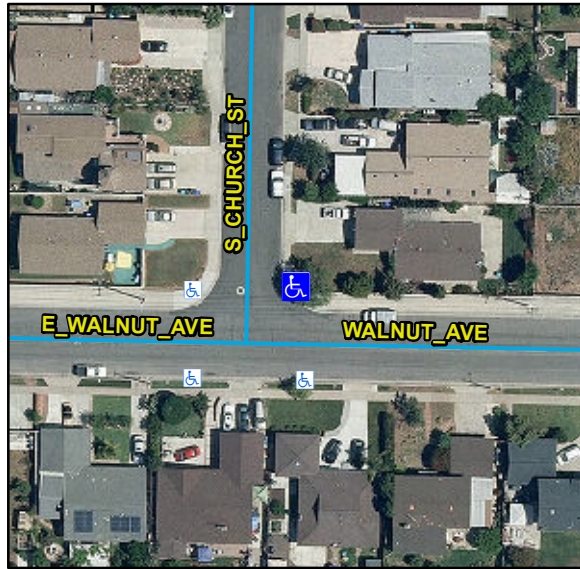
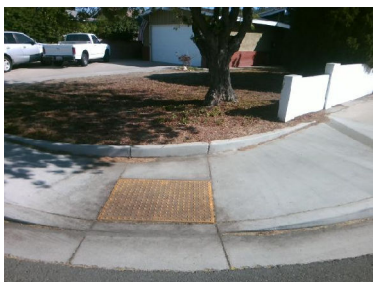
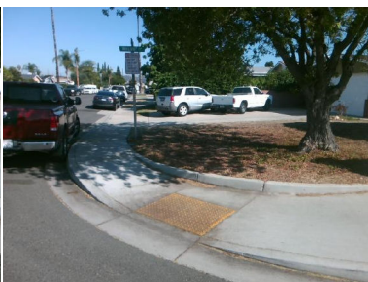
| Compliance | Description | Data | Compliance | Description | Data |
|---|---|---|---|---|---|
| No | Gutter Ponding | Yes | Yes | Curb Slope | 3 |
| No | Gutter Run Slope (%) | 5.9 | | Road Cross Slope (%) | 0 |

Remove & Replace Gutter.

R302.7, R304.5.4, STD 1115
