Access Compliance Report Public Rights-of-Way (Curb Ramps)

Main Street: **E WALNUT AVE** Cross Street: **S CHURCH ST** Location: **NW**

ADA ID: **RPAT211020102043** Ramp Type: **Type 4 - Parallel** Initial Pass/Fail: **Pass** Overall Compliance: **No** Severity Score: **5**

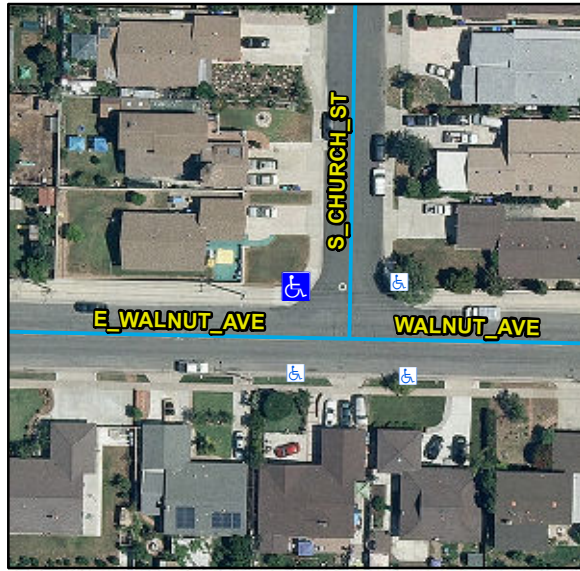
Compliance	Description	Data	Compliance	Description	Data
N/A	Ramp Length LT (in)	96	N/A	Ramp Length RT (in)	115
Yes	Ramp Width LT (in)	80	Yes	Ramp Width RT (in)	80
Yes	Ramp Run Slope LT (%)	6.5	Yes	Ramp Run Slope RT (%)	6.7
Yes	Ramp Cross Slope LT (%)	1.3	Yes	Ramp Cross Slope RT (%)	0.4
N/A	Landing Present	Yes	Yes	DWS Provided	Yes
N/A	Landing Length (in)	80	Yes	DWS Contrast	Yes
Yes	Landing Width (in)	49	Yes	DWS Length (in)	36
Yes	Landing Run Slope (%)	0.3	Yes	DWS Full Width	Yes
Yes	Landing Cross Slope (%)	0.3		DWS Offset Type	Single
N/A	Landing Movement Obstructed?	No	Yes	DWS Offset Left (in)	0
	Landing Movement Type	Curb	Yes	DWS Offset Right (in)	N/A
N/A	Landing Shared	No			
N/A	Clear Space	Yes			
N/A	Clear Space To Crosswalk (in)	48			
N/A	Marked Crosswalk 1	No	N/A	Marked Crosswalk 2	No
	Crossing 1 Direction	S		Crossing 2 Direction	E
	Marked Crosswalk 1 Width (in)	N/A		Marked Crosswalk 2 Width (in)	N/A
N/A	Ramp Inside Crosswalk 1	N/A	N/A	Ramp Inside Crosswalk 2	N/A

Crossing 1 Slope (%)	3.9		Crossing 2 Slope (%)	3.9
	Crossing 1 Cross Slope (%)	0.4		Crossing 2 Cross Slope (%)	0.6
Yes	Gutter Ponding	No	No	Curb Slope	9.8
Yes	Gutter Lip Height (in)	0		Road Run Slope (%)	1.3
No	Gutter Run Slope (%)	5.5		Road Cross Slope (%)	5.5
Yes	Gutter Cross Slope (%)	1	Yes	Perpendicular Joint Present	Yes
Yes	Overall Surface Condition	Acceptable			
	Cross Gutter Present?	No		Spandrel Present?	No
	Replace Cross Gutter?	N/A		Replace Spandrel?	N/A

Possible Solutions:
Remove & Replace Curb Slope. Remove & Replace Gutter.
