# Access Compliance Report Public Rights-of-Way (Curb Ramps)

Main Street: EARLHAM\_ST Cross Street: E\_WALNUT\_AVE Location: NE

ADA ID: RPAT211020102724 Ramp Type: Type 4 - Parallel Initial Pass/Fail: Pass Overall Compliance: No Severity Score: 5

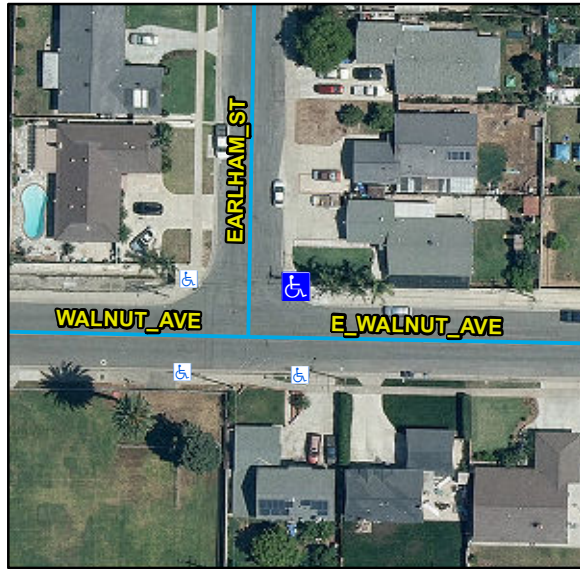
| Compliance | Description | Data | Compliance | Description | Data |
|---|---|---|---|---|---|
| No | Gutter Run Slope (%) | 6.8 | | Road Cross Slope (%) | 1.9 |

Possible Solutions:

Remove & Replace Gutter.

R304.5.4, STD 1115
