# Access Compliance Report Public Rights-of-Way (Curb Ramps)

Main Street: WALNUT\_AVE Cross Street: EARLHAM\_ST Location: NW

ADA ID: RPAT211020103248 Ramp Type: Type 1 - Perpendicular Diagonal Initial Pass/Fail: Fail Overall Compliance: No Severity Score: 19

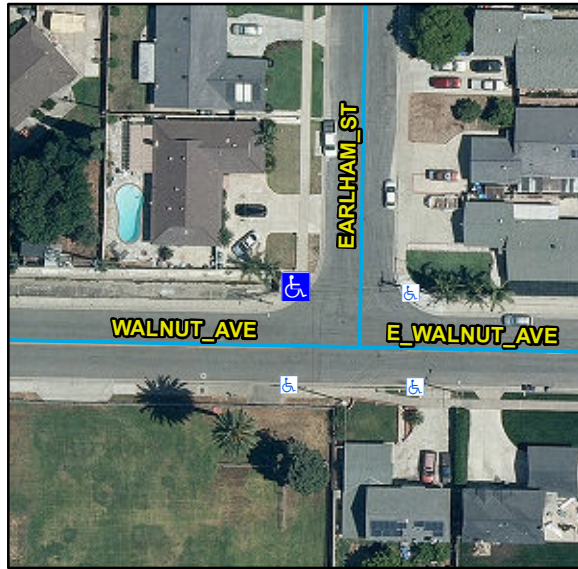
| Compliance | Description | Data | Compliance | Description | Data |
|---|---|---|---|---|---|
| No | Ramp Width (in) | 40 | | | N/A |
| No | Ramp Run Slope (%) | 8.6 | N/A | Flare Slope LT (%) | N/A |

Remove & Replace Curb Ramp With Two New Directional Ramps or Equivalent.
