# Access Compliance Report Public Rights-of-Way (Curb Ramps)

| Main Street: DARMEL_PL | | Cross Street: DARMEL_PL | | Location: | NE |
| ADA ID: RPAT211020120513 | Ramp Type: Type 4 - Parallel | Initial Pass/Fail: Fail | Overall Compliance: No | Severity Score: | 16 |

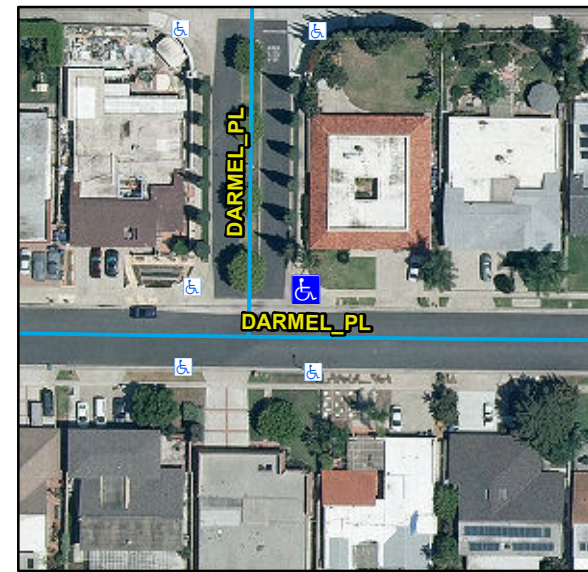
| Compliance | Description | Data | Compliance | Description | Data |
|---|---|---|---|---|---|
| No | Ramp Run Slope LT (%) | 9.3 | Yes | Ramp Run Slope RT (%) | 6 |
| No | Ramp Cross Slope LT (%) | 4.3 | No | Ramp Cross Slope RT (%) | 3.3 |

**Remove & Replace Curb Ramp With Two New Directional Ramps or Equivalent.**

**R204.3, R304.3.2, R304.5.3, STD 1115**
