# Access Compliance Report Public Rights-of-Way (Curb Ramps)

Main Street: FAIRHAVEN\_AVE Cross Street: DARMEL\_PL Location: SE

ADA ID: RPAT211020122048 Ramp Type: Type 4 - Parallel Initial Pass/Fail: Fail Overall Compliance: No Severity Score: 2

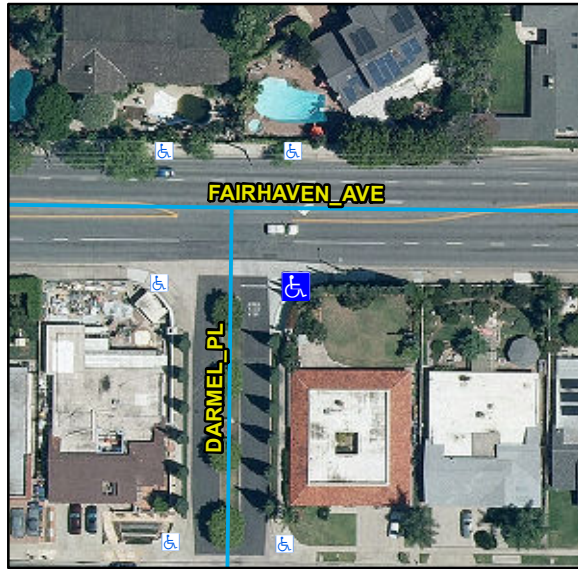
| Compliance | Description | Data | Compliance | Description | Data |
|---|---|---|---|---|---|
| Yes | Ramp Cross Slope LT (%) | 1 | No | Ramp Cross Slope RT (%) | 3.3 |

Remove & Replace Curb Ramp With Two New Directional Ramps or Equivalent.

R304.5.3, STD 1115
