# Access Compliance Report Public Rights-of-Way (Curb Ramps)

Main Street: DARMEL\_PL Cross Street: FAIRHAVEN\_AVE Location: SW

ADA ID: RPAT211020122506 Ramp Type: Type 4 - Parallel Initial Pass/Fail: Fail Overall Compliance: No Severity Score: 16

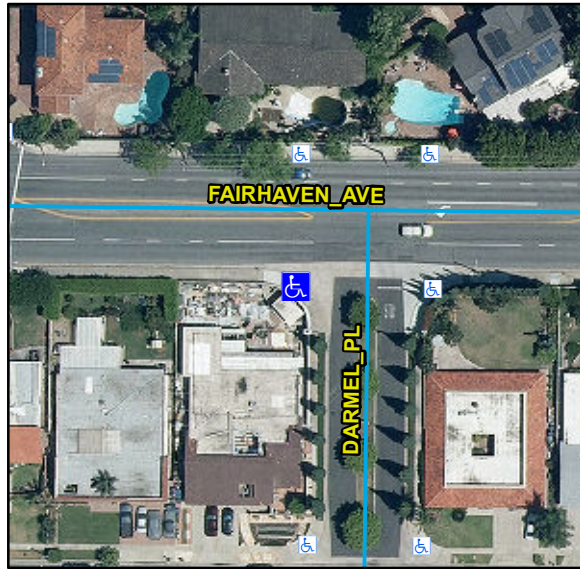
| Compliance | Description | Data | Compliance | Description | Data |
|---|---|---|---|---|---|
| No | Ramp Run Slope LT (%) | 9.6 | Yes | Ramp Run Slope RT (%) | 4.8 |
| No | Ramp Cross Slope LT (%) | 2.9 | No | Ramp Cross Slope RT (%) | 3.2 |

**Remove & Replace Curb Ramp With Two New Directional Ramps or Equivalent.**
