# Access Compliance Report Public Rights-of-Way (Curb Ramps)

Main Street: LORETTA\_DR Cross Street: FAIRHAVEN\_AVE Location: SW

ADA ID: RPAT211021091952 Ramp Type: Type 1 - Perpendicular Diagonal Initial Pass/Fail: Fail Overall Compliance: No Severity Score: 2

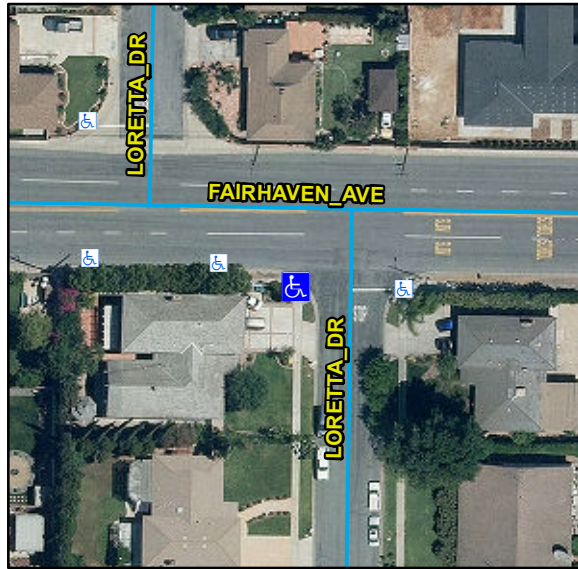
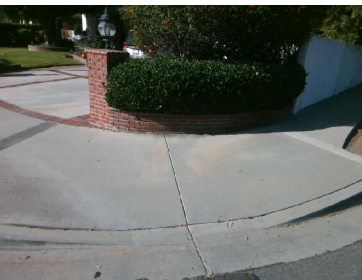
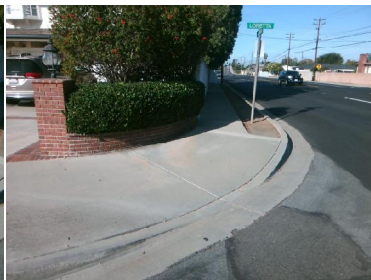
| Compliance | Description | Data | Compliance | Description | Data |
|---|---|---|---|---|---|
| No | Ramp Cross Slope (%) | 2.7 | N/A | Flare Traversable LT | N/A |

Remove & Replace Curb Ramp With Two New Directional Ramps or Equivalent.

R304.5.3, STD 1115
