# Access Compliance Report Public Rights-of-Way (Curb Ramps)

Main Street: FAIRHAVEN\_AVE Cross Street: LORETTA\_DR Location: SE

ADA ID: RPAT211021092531 Ramp Type: Type 1 - Perpendicular Diagonal Initial Pass/Fail: Fail Overall Compliance: No Severity Score: 2

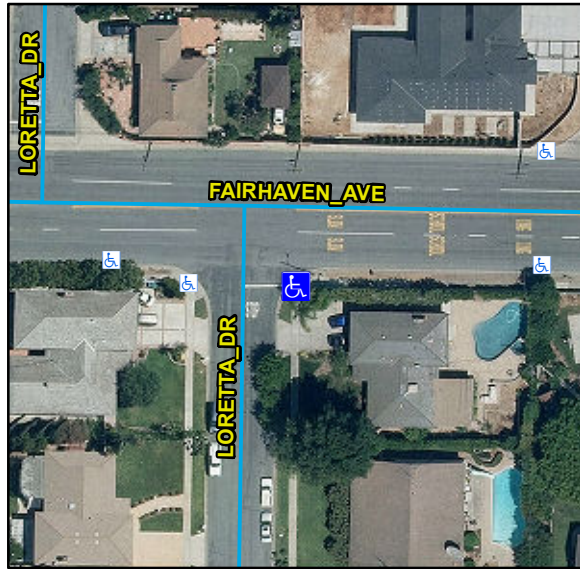
| Compliance | Description | Data | Compliance | Description | Data |
|---|---|---|---|---|---|
| No | Ramp Cross Slope (%) | 2.7 | N/A | Flare Traversable LT | N/A |

Remove & Replace Curb Ramp With Two New Directional Ramps or Equivalent.

R304.2.2, R304.5.3, STD 1115
