# Access Compliance Report Public Rights-of-Way (Curb Ramps)

Main Street: FAIRHAVEN\_AVE Cross Street: S LAURINDA\_LN Location: NW

ADA ID: RPAT211021094220 Ramp Type: Type 1 - Perpendicular Diagonal Initial Pass/Fail: Pass Overall Compliance: No Severity Score: 20

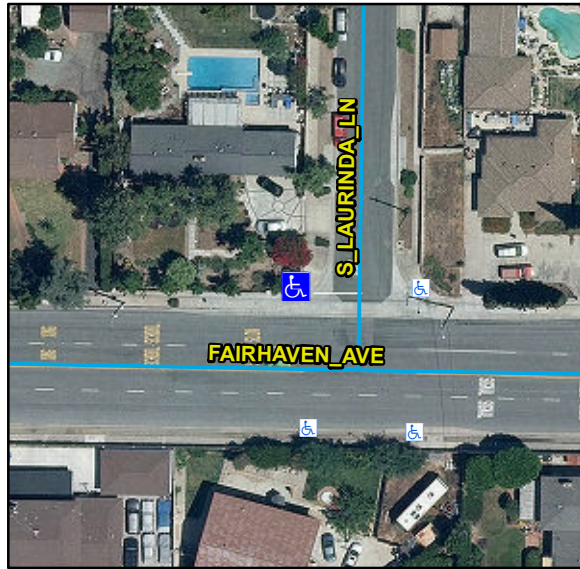
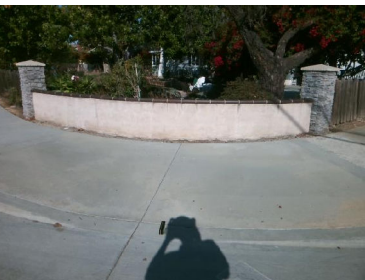
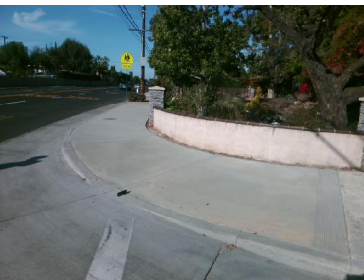
| Compliance | Description | Data | Compliance | Description | Data |
|---|---|---|---|---|---|
| No | Landing Width (in) | N/A | N/A | Flare Slope RT (%) | 6.4 |
| No | Landing Run Slope (%) | N/A | N/A | Flare Traversable RT | No |
| No | Landing Cross Slope (%) | N/A | No | DWS Provided | No |
| N/A | Landing Movement Obstructed? | Yes | N/A | DWS Contrast | N/A |
| | Landing Movement Type | Wall | N/A | DWS Length (in) | N/A |

Remove & Replace Curb Ramp With Two New Directional Ramps or Equivalent.
