# Access Compliance Report Public Rights-of-Way (Curb Ramps)

Main Street: S LAURINDA LN Cross Street: FAIRHAVEN\_AVE Location: NE

ADA ID: RPAT211021094557 Ramp Type: Type 1 - Perpendicular Diagonal Initial Pass/Fail: Fail Overall Compliance: No Severity Score: 2

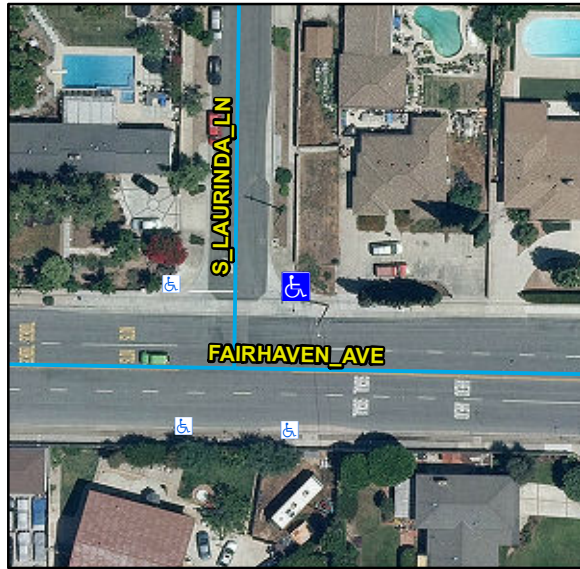
| Compliance | Description | Data | Compliance | Description | Data |
|---|---|---|---|---|---|
| No | Ramp Cross Slope (%) | 2.7 | N/A | Flare Traversable LT | N/A |
| N/A | Gutter Ponding | N/A | No | Curb Slope | 11.7 |

Remove & Replace Curb Ramp With Two New Directional Ramps or Equivalent.

R304.2.2, R204.3, R304.5.3, STD 1115
