# Access Compliance Report Public Rights-of-Way (Curb Ramps)

Main Street: E\_STEARNS\_AVE Cross Street: S\_LAURINDA\_LN Location: SE

ADA ID: RPAT211021094947 Ramp Type: Type 1 - Perpendicular Diagonal Initial Pass/Fail: Fail Overall Compliance: No Severity Score: 19

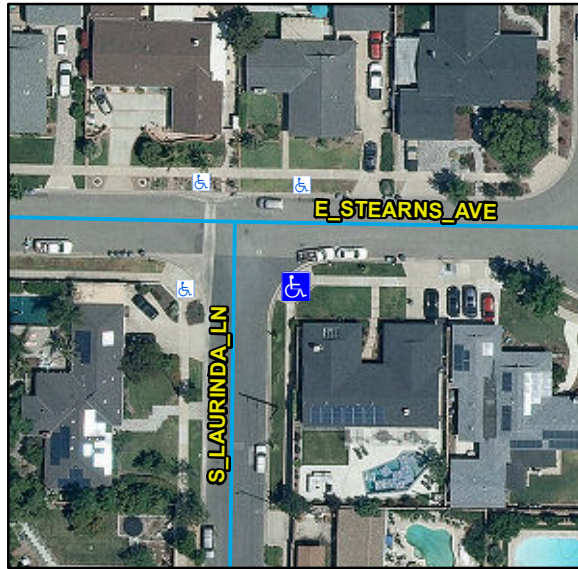
| Compliance | Description | Data | Compliance | Description | Data |
|---|---|---|---|---|---|
| No | Ramp Width (in) | 45 | | | N/A |
| No | Ramp Run Slope (%) | 11 | N/A | Flare Slope LT (%) | N/A |

Remove & Replace Curb Ramp With Two New Directional Ramps or Equivalent.

R304.2.2, R304.5.1, STD 1115
