# Access Compliance Report Public Rights-of-Way (Curb Ramps)

Main Street: S LAURINDA LN Cross Street: E STEARNS AVE Location: SW

ADA ID: RPAT211021095304 Ramp Type: Type 1 - Perpendicular Diagonal Initial Pass/Fail: Fail Overall Compliance: No Severity Score: 19

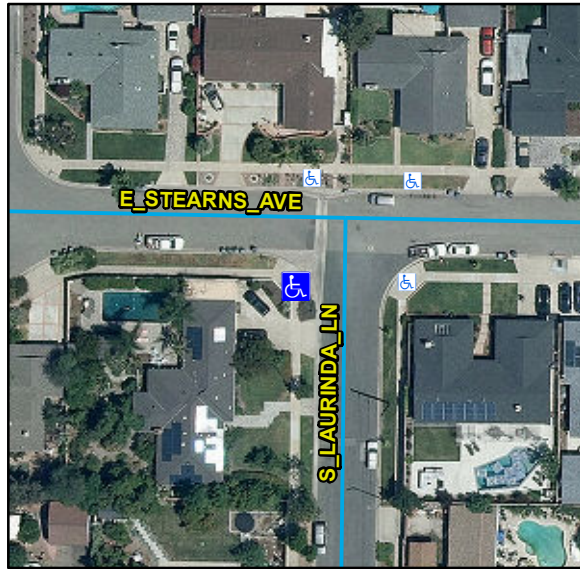
| Compliance | Description | Data | Compliance | Description | Data |
|---|---|---|---|---|---|
| No | Ramp Width (in) | 47 | | | N/A |
| No | Ramp Run Slope (%) | 11.5 | N/A | Flare Slope LT (%) | N/A |

Remove & Replace Curb Ramp With Two New Directional Ramps or Equivalent.
