# Access Compliance Report Public Rights-of-Way (Curb Ramps)

Main Street: FAIRHAVEN\_AVE Cross Street: FLINT\_DR Location: S

ADA ID: RPAT211021102456 Ramp Type: Type 1 - Perpendicular Diagonal Initial Pass/Fail: Fail Overall Compliance: No Severity Score: 30

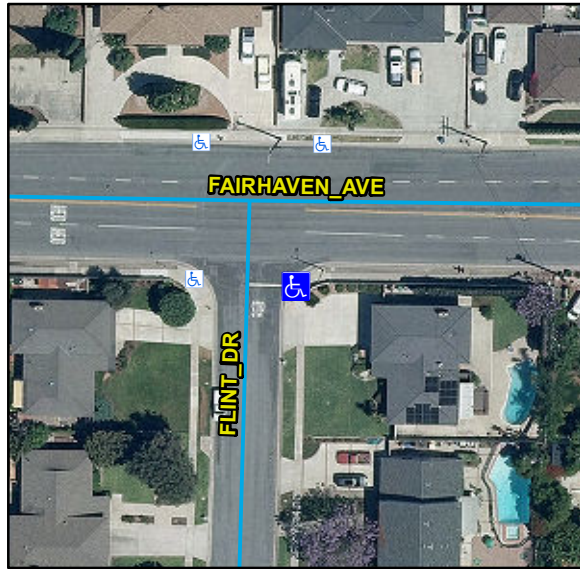
## Field Measurements/Component Compliance

| Compliance | Description | Data | Compliance | Description | Data |
|---|---|---|---|---|---|
| No | Ramp Run Slope (%) | 9.6 | N/A | Flare Slope LT (%) | N/A |
| No | Ramp Cross Slope (%) | 6.7 | N/A | Flare Traversable LT | N/A |

Remove & Replace Curb Ramp With Two New Directional Ramps or Equivalent.
