# Access Compliance Report Public Rights-of-Way (Curb Ramps)

Main Street: FLINT\_DR Cross Street: FAIRHAVEN\_AVE Location: SW

ADA ID: RPAT211021102817 Ramp Type: Type 1 - Perpendicular Diagonal Initial Pass/Fail: Fail Overall Compliance: No Severity Score: 16

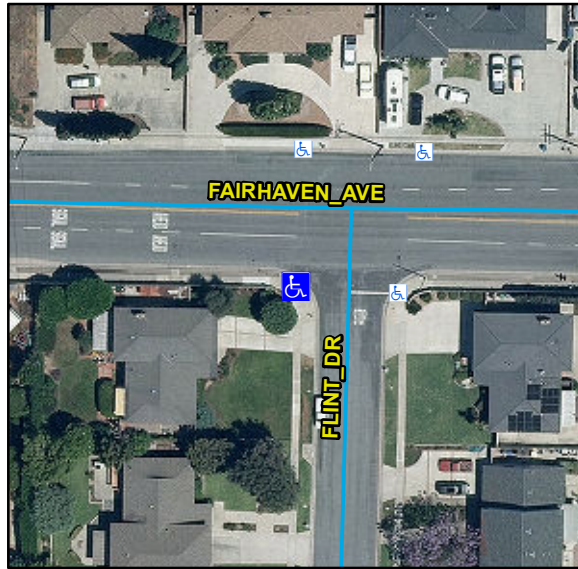
| Compliance | Description | Data | Compliance | Description | Data |
|---|---|---|---|---|---|
| No | Ramp Run Slope (%) | 9.6 | N/A | Flare Slope LT (%) | N/A |
| No | Ramp Cross Slope (%) | 4 | N/A | Flare Traversable LT | N/A |

Remove & Replace Curb Ramp With Two New Directional Ramps or Equivalent.

R304.2.2, R304.5.3, STD 1115

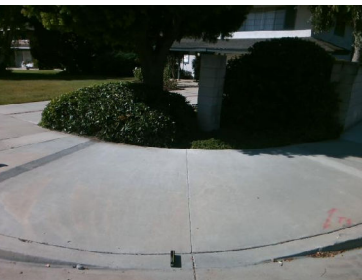
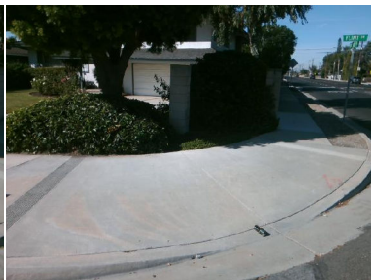
| Compliance | Description | Data | Compliance | Description | Data |
|---|---|---|---|---|---|
| Yes | Overall Surface Condition: Acceptable | | Yes | Perp Joint Present | Yes |
