# Access Compliance Report Public Rights-of-Way (Curb Ramps)

Main Street: FAIRHAVEN\_AVE Cross Street: PROSPECT\_AVE Location: SE

ADA ID: RPAT211021104326 Ramp Type: Type 1 - Perpendicular Diagonal Initial Pass/Fail: Fail Overall Compliance: No Severity Score: 2

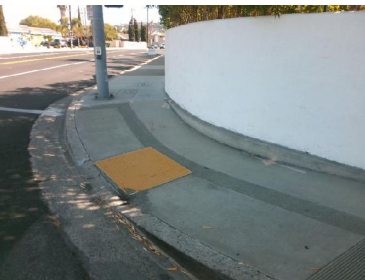
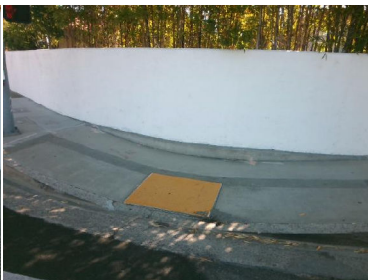
| Compliance | Description | Data | Compliance | Description | Data |
|---|---|---|---|---|---|
| No | Ramp Cross Slope (%) | 2.5 | N/A | Flare Traversable LT | N/A |

Remove & Replace Curb Ramp With Two New Directional Ramps or Equivalent.
