# Access Compliance Report Public Rights-of-Way (Curb Ramps)

Main Street: FAIRHAVEN\_AVE Cross Street: PROSPECT\_AVE Location: NE

ADA ID: RPAT211021105341 Ramp Type: Type 1 - Perpendicular Initial Pass/Fail: Fail Overall Compliance: No Severity Score: 19

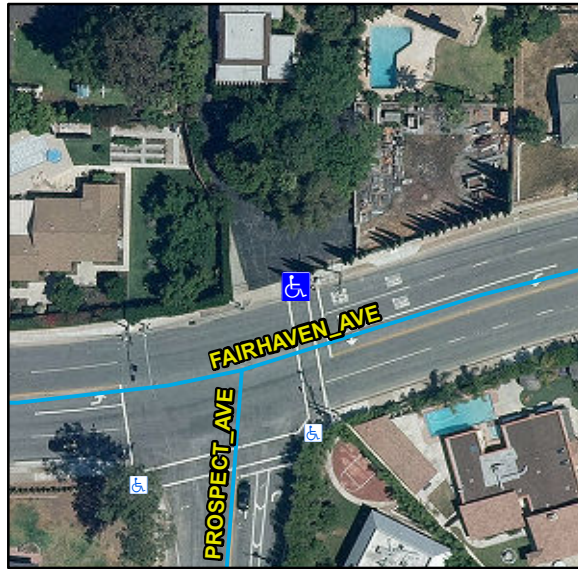
| Compliance | Description | Data | Compliance | Description | Data |
|---|---|---|---|---|---|
| No | Ramp Width (in) | 47 | | | N/A |
| No | Ramp Run Slope (%) | 8.7 | N/A | Flare Slope LT (%) | N/A |

Remove & Replace Entire Ramp.

R304.5.1, R304.2.2, STD 1115

Total Cost: \$ 3080
