# Access Compliance Report Public Rights-of-Way (Curb Ramps)

Main Street: RAINBOW\_DR Cross Street: RED\_HILL\_AVE Location: SW

ADA ID: RPAT211021140740 Ramp Type: Type 1 - Perpendicular Diagonal Initial Pass/Fail: Pass Overall Compliance: No Severity Score: 19

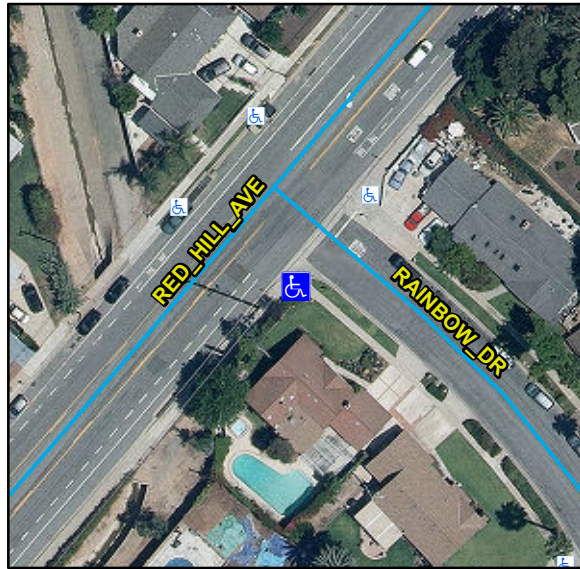
| Compliance | Description | Data | Compliance | Description | Data |
|---|---|---|---|---|---|
| No | Landing Run Slope (%) | 5.4 | N/A | Flare Traversable RT | No |
| No | Landing Cross Slope (%) | 2.8 | No | DWS Provided | No |

Remove & Replace Curb Ramp With Two New Directional Ramps or Equivalent.
