# Access Compliance Report Public Rights-of-Way (Curb Ramps)

Main Street: RED\_HILL\_AVE Cross Street: RAINBOW\_DR Location: SE

ADA ID: RPAT211021141203 Ramp Type: Type 1 - Perpendicular Diagonal Initial Pass/Fail: Pass Overall Compliance: No Severity Score: 14

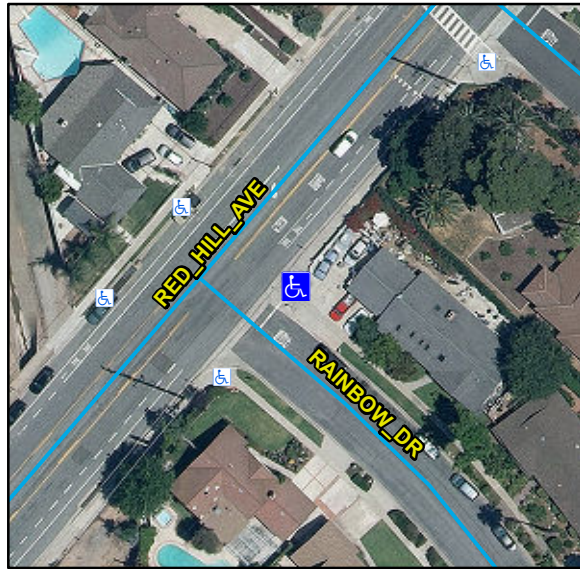
| Compliance | Description | Data | Compliance | Description | Data |
|---|---|---|---|---|---|
| No | Landing Run Slope (%) | 2.8 | N/A | Flare Traversable RT | No |
| Yes | Landing Cross Slope (%) | 0.2 | No | DWS Provided | No |
| Yes | Gutter Ponding | No | No | Curb Slope | 6.6 |

**Remove & Replace Curb Ramp With Two New Directional Ramps or Equivalent.**

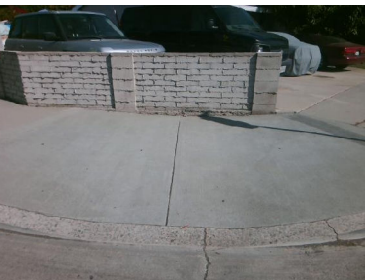
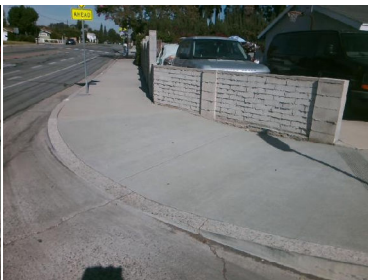
| Compliance | Description | Data | Compliance | Description | Data |
|---|---|---|---|---|---|
| Yes | Overall Surface Condition: Acceptable | | No | Perp Joint Present | No |
