# Access Compliance Report Public Rights-of-Way (Curb Ramps)

Main Street: CAMEO\_DR Cross Street: RED\_HILL\_AVE Location: N

ADA ID: RPAT211021141907 Ramp Type: Type 3 - Combination 1 Initial Pass/Fail: Fail Overall Compliance: No Severity Score: 20

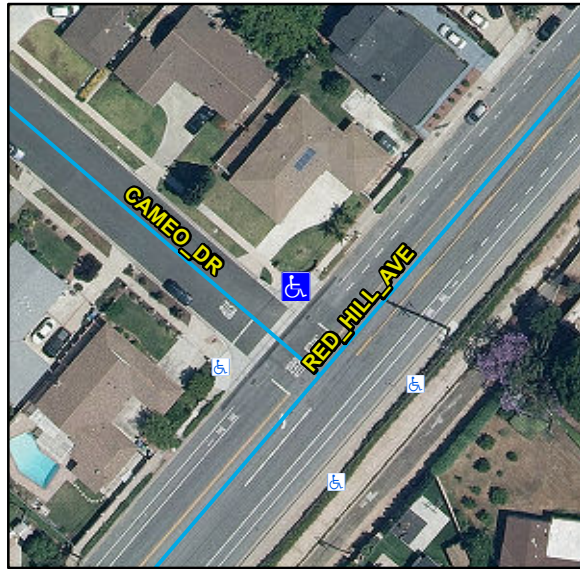
| Compliance | Description | Data | Compliance | Description | Data |
|---|---|---|---|---|---|
| N/A | Ramp Length LT (in) | 77 | N/A | Ramp Length RT (in) | 89 |
| Yes | Ramp Width LT (in) | 58 | No | Ramp Width RT (in) | 46 |
| No | Ramp Run Slope LT (%) | 8.4 | No | Ramp Run Slope RT (%) | 9.6 |
| No | Ramp Cross Slope LT (%) | 2.2 | No | Ramp Cross Slope RT (%) | 2.1 |

Remove & Replace Curb Ramp With Two New Directional Ramps or Equivalent.

R304.2.2, R304.5.1, R304.3.2, R304.5.3, STD 1115

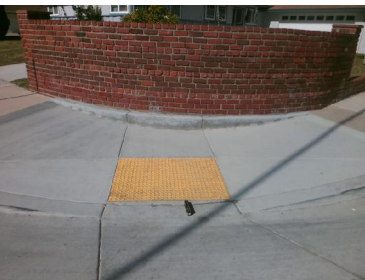
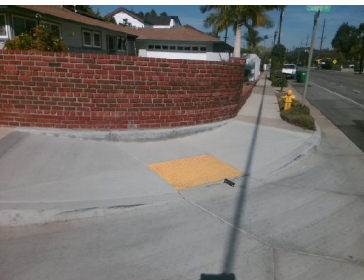
| Compliance | Description | Data | Compliance | Description | Data |
|---|---|---|---|---|---|
| Yes | Overall Surface Condition: Acceptable | | | | |
| | Cross Gutter Present? | Yes | | Spandrel Present? | Yes |
