# Access Compliance Report Public Rights-of-Way (Curb Ramps)

Main Street: RED\_HILL\_AVE Cross Street: CAMEO\_DR Location: NW

ADA ID: RPAT211021142232 Ramp Type: Type 3 - Combination 1 Initial Pass/Fail: Fail Overall Compliance: No Severity Score: 15

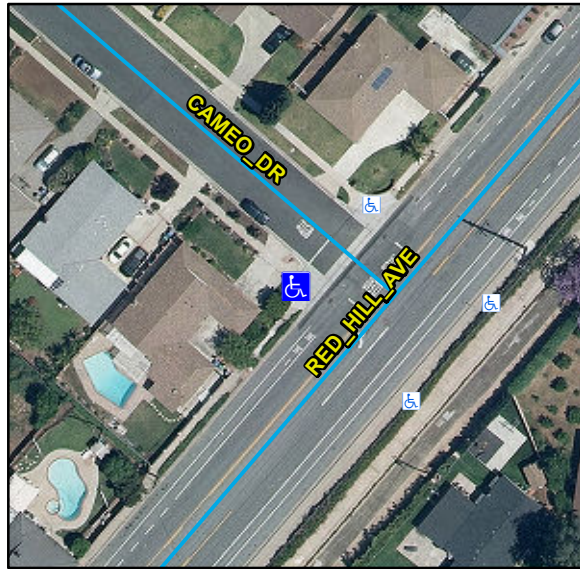
| Compliance | Description | Data | Compliance | Description | Data |
|---|---|---|---|---|---|
| Yes | Ramp Run Slope LT (%) | 5.6 | No | Ramp Run Slope RT (%) | 11.8 |

**Remove & Replace Curb Ramp With Two New Directional Ramps or Equivalent.**

**R304.2.2, R304.3.2, STD 1115**
