# Access Compliance Report Public Rights-of-Way (Curb Ramps)

Main Street: KENNETH\_DR Cross Street: RED\_HILL\_AVE Location: N

ADA ID: RPAT211021142646 Ramp Type: Type 3 - Combination 1 Initial Pass/Fail: Fail Overall Compliance: No Severity Score: 5

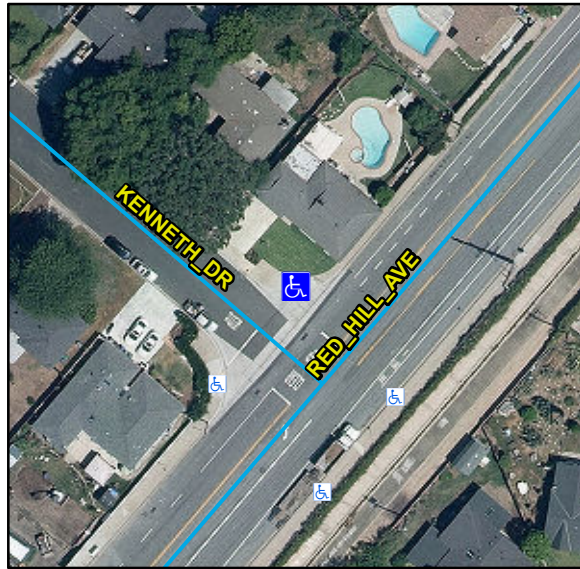
| Compliance | Description | Data | Compliance | Description | Data |
|---|---|---|---|---|---|
| Yes | Ramp Width LT (in) | 57 | No | Ramp Width RT (in) | 46 |
| No | Ramp Cross Slope LT (%) | 2.8 | No | Ramp Cross Slope RT (%) | 3.4 |

Remove & Replace Curb Ramp With Two New Directional Ramps or Equivalent.

R304.2.2, R304.5.1, R304.5.3, STD 1115
