# Access Compliance Report

## Public Rights-of-Way

### (Curb Ramps)

Main Street: RED\_HILL\_AVE Cross Street: KENNETH\_DR Location: NW

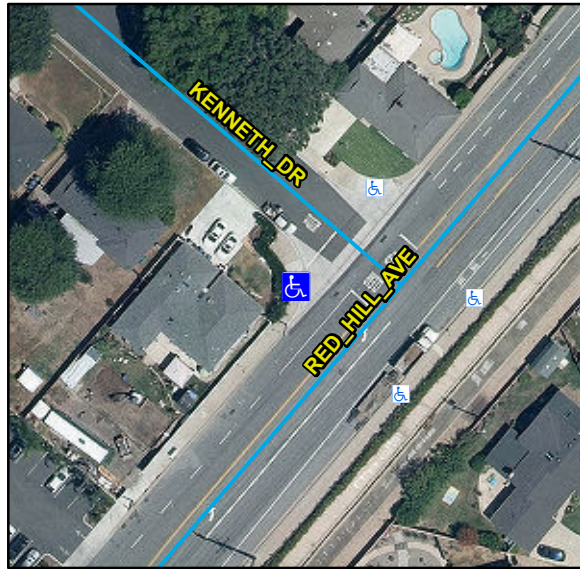
ADA ID: RPAT211021143127 Ramp Type: Type 3 - Combination 1 Initial Pass/Fail: Fail Overall Compliance: No Severity Score: 16

| Compliance | Description | Data | Compliance | Description | Data |
|---|---|---|---|---|---|
| Yes | Ramp Run Slope LT (%) | 4.6 | No | Ramp Run Slope RT (%) | 10.1 |
| No | Ramp Cross Slope LT (%) | 2.3 | Yes | Ramp Cross Slope RT (%) | 0.2 |

Remove & Replace Curb Ramp With Two New Directional Ramps or Equivalent. Remove & Replace Sidewalk.

R304.2.2, R304.5.3, R304.3.2, STD 1115

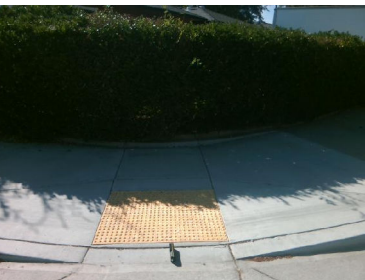
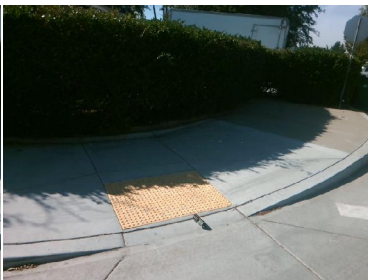
| Compliance | Description | Data | Compliance | Description | Data |
|---|---|---|---|---|---|
| Yes | Overall Surface Condition: Acceptable | | | | |
