# Access Compliance Report Public Rights-of-Way (Curb Ramps)

| Main Street: <b>BROWNING_AVE</b> | | Cross Street: <b>BENT_TWIG_LN</b> | | Location: | <b>NW</b> |
| ADA ID: <b>RPAT211021150556</b> | Ramp Type: <b>Type 4 - Parallel</b> | Initial Pass/Fail: <b>Fail</b> | Overall Compliance: <b>No</b> | Severity Score: | <b>2</b> |

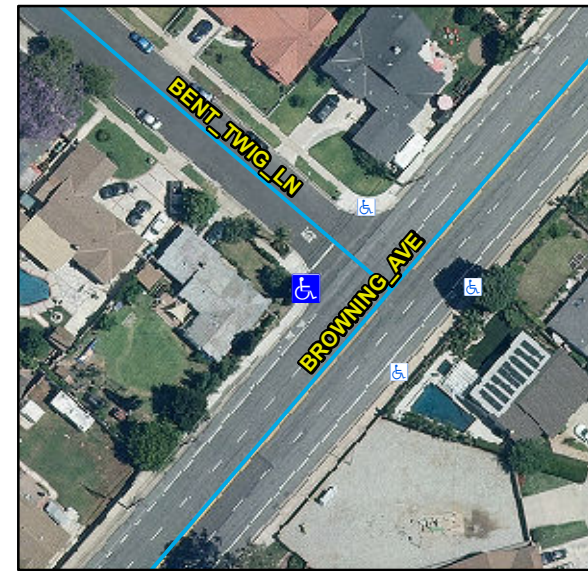
| Compliance | Description | Data | Compliance | Description | Data |
|---|---|---|---|---|---|
| <b>No</b> | Ramp Cross Slope LT (%) | <b>3.6</b> | <b>No</b> | Ramp Cross Slope RT (%) | <b>2.4</b> |

**Remove & Replace Curb Ramp With Two New Directional Ramps or Equivalent.**

**R304.5.3, STD 1115**
