# Access Compliance Report Public Rights-of-Way (Curb Ramps)

Main Street: BENT\_TWIG\_LN Cross Street: BROWNING\_AVE Location: N

ADA ID: RPAT211021150902 Ramp Type: Type 1 - Perpendicular Diagonal Initial Pass/Fail: Pass Overall Compliance: No Severity Score: 14

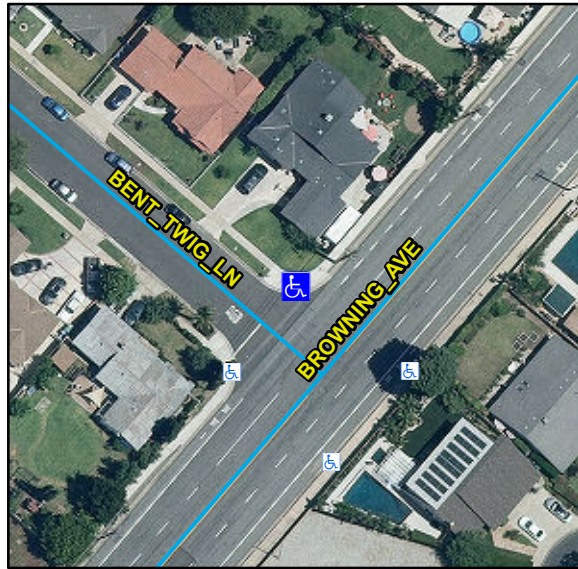
| Compliance | Description | Data | Compliance | Description | Data |
|---|---|---|---|---|---|
| Yes | Landing Width (in) | 49 | No | Flare Slope RT (%) | 11.5 |
| No | Landing Cross Slope (%) | 2.7 | Yes | DWS Provided | Yes |
| No | Gutter Run Slope (%) | 7.4 | | Road Cross Slope (%) | 2.3 |
| No | Gutter Cross Slope (%) | 4.2 | | | |

Remove & Replace Curb Ramp With Two New Directional Ramps or Equivalent. Remove & Replace Gutter.
