# Access Compliance Report Public Rights-of-Way (Curb Ramps)

Main Street: BELLEFORD\_RD Cross Street: BROWNING\_AVE Location: S

ADA ID: RPAT211021151535 Ramp Type: Type 1 - Perpendicular Diagonal Initial Pass/Fail: Pass Overall Compliance: No Severity Score: 10

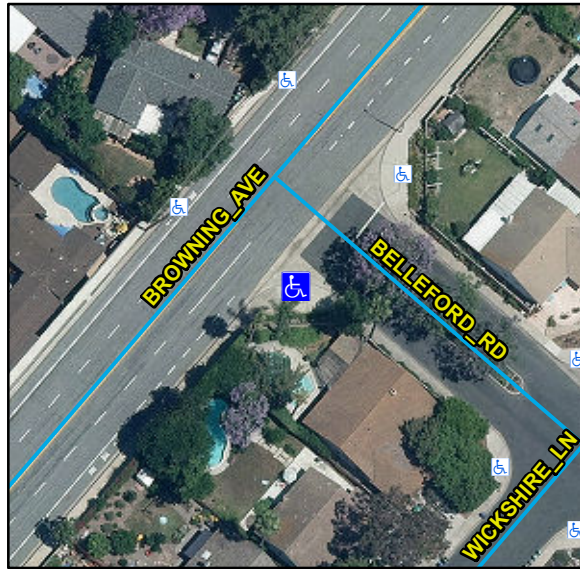
| Compliance | Description | Data | Compliance | Description | Data |
|---|---|---|---|---|---|
| Yes | Landing Cross Slope (%) | 1.3 | No | DWS Provided | No |
| Yes | Gutter Ponding | No | No | Curb Slope | 7.8 |

**Remove & Replace Curb Ramp With Two New Directional Ramps or Equivalent.**

**R304.2.2, R204.3, R304.2.1, R305, STD 1115**
