# Access Compliance Report Public Rights-of-Way (Curb Ramps)

Main Street: BROWNING\_AVE Cross Street: BELLEFORD\_RD Location: E

ADA ID: RPAT211021151909 Ramp Type: Type 1 - Perpendicular Diagonal Initial Pass/Fail: Fail Overall Compliance: No Severity Score: 15

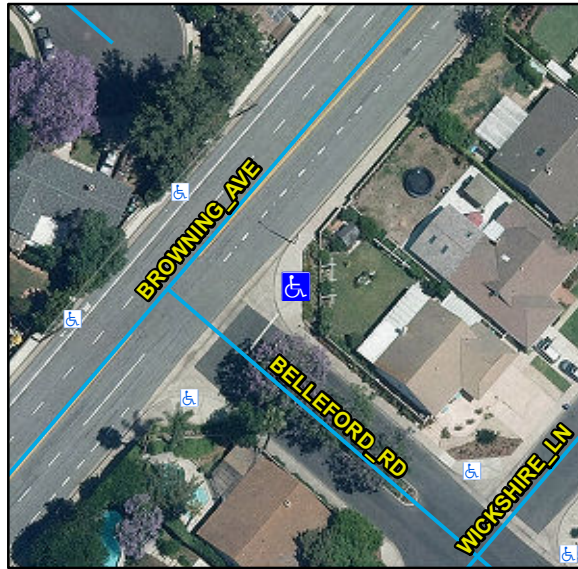
| Compliance | Description | Data | Compliance | Description | Data |
|---|---|---|---|---|---|
| No | Ramp Run Slope (%) | 8.5 | N/A | Flare Slope LT (%) | N/A |

Remove & Replace Curb Ramp With Two New Directional Ramps or Equivalent.

R304.2.2, R204.3, STD 1115
