# Access Compliance Report Public Rights-of-Way (Curb Ramps)

Main Street: FAIRHAVEN\_AVE Cross Street: OLYMPIA\_WAY Location: NW

ADA ID: RPAT211022090147 Ramp Type: Type 4 - Parallel Initial Pass/Fail: Fail Overall Compliance: No Severity Score: 15

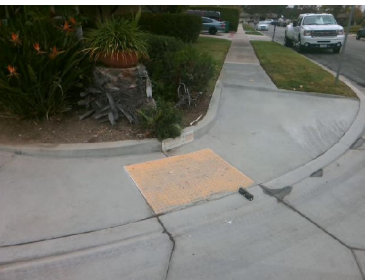
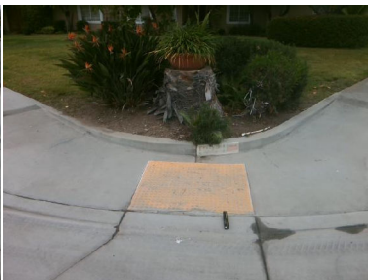
| Compliance | Description | Data | Compliance | Description | Data |
|---|---|---|---|---|---|
| No | Ramp Cross Slope LT (%) | 6.9 | Yes | Ramp Cross Slope RT (%) | 1.3 |

Remove & Replace Curb Ramp With Two New Directional Ramps or Equivalent.

R304.5.3, STD 1115
