# Access Compliance Report Public Rights-of-Way (Curb Ramps)

Main Street: OLYMPIA\_WAY Cross Street: FAIRHAVEN\_AVE Location: NE

ADA ID: RPAT211022090534 Ramp Type: Type 4 - Parallel Initial Pass/Fail: Fail Overall Compliance: No Severity Score: 2

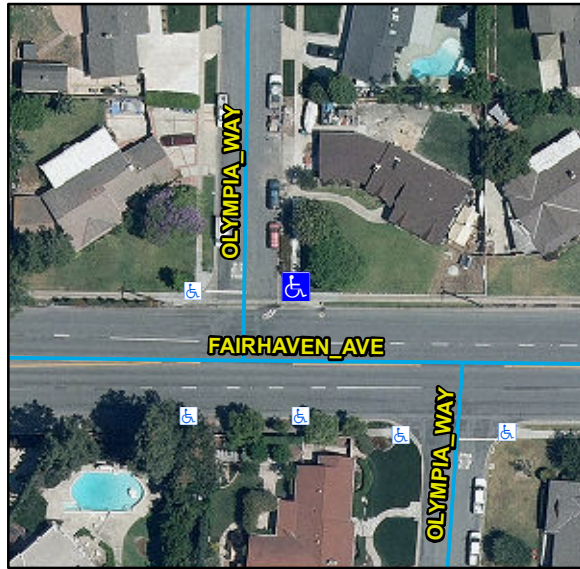
| Compliance | Description | Data | Compliance | Description | Data |
|---|---|---|---|---|---|
| No | Ramp Cross Slope LT (%) | 3.5 | No | Ramp Cross Slope RT (%) | 4.1 |

**Remove & Replace Curb Ramp With Two New Directional Ramps or Equivalent.**

**R304.5.3, STD 1115**
