# Access Compliance Report Public Rights-of-Way (Curb Ramps)

Main Street: OLYMPIA\_WAY Cross Street: FAIRHAVEN\_AVE Location: SW

ADA ID: RPAT211022090944 Ramp Type: Type 6 - Directional 1 Initial Pass/Fail: Fail Overall Compliance: No Severity Score: 2

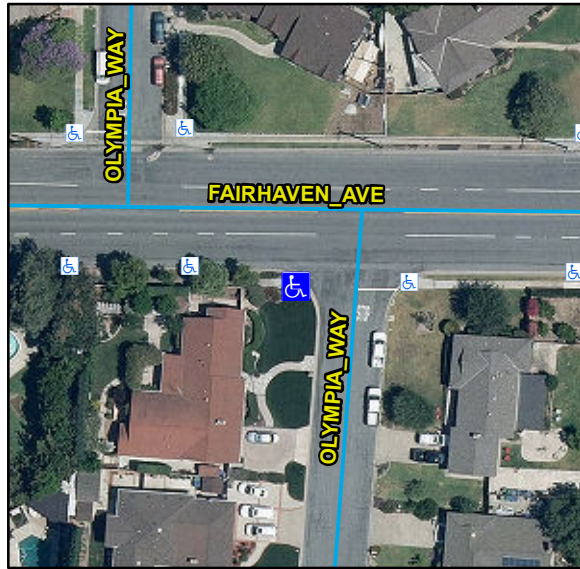
| Compliance | Description | Data | Compliance | Description | Data |
|---|---|---|---|---|---|
| No | Ramp Cross Slope (%) | 2.9 | N/A | Flare Traversable LT | N/A |

**Remove & Replace Curb Ramp With Two New Directional Ramps or Equivalent.**

**R304.5.3, STD 1115**
