# Access Compliance Report Public Rights-of-Way (Curb Ramps)

Main Street: FAIRHAVEN\_AVE Cross Street: OLYMPIA\_WAY Location: SE

ADA ID: RPAT211022091405 Ramp Type: Type 6 - Directional 1 Initial Pass/Fail: Fail Overall Compliance: No Severity Score: 16

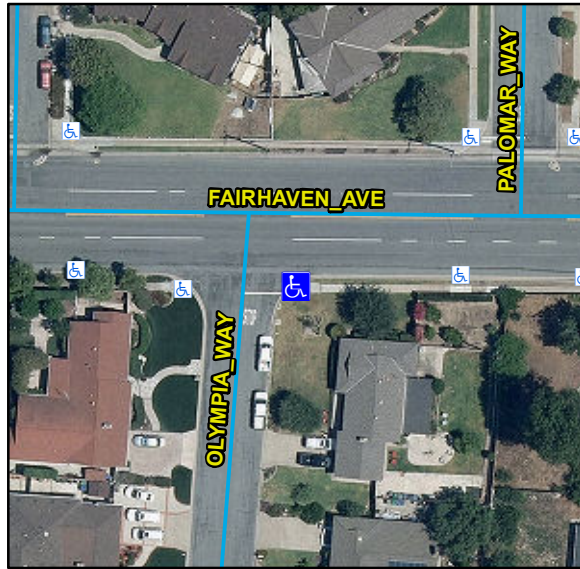
| Compliance | Description | Data | Compliance | Description | Data |
|---|---|---|---|---|---|
| No | Ramp Run Slope (%) | 9.5 | N/A | Flare Slope LT (%) | N/A |
| No | Ramp Cross Slope (%) | 4.2 | N/A | Flare Traversable LT | N/A |

Remove & Replace Curb Ramp With Two New Directional Ramps or Equivalent.

R304.2.2, R304.5.3, STD 1115
